XXXX COMMUNITY BUILDING ENERGY AUDIT AND RENEWABLE ENERGY OPTIONS APPRAISAL

REPORT PREPARED BY EWAN BOYD OF GREEN
COMMUNITY BUILDINGS CIC
teclimited@btinternet.com
XXth XXXX 201X

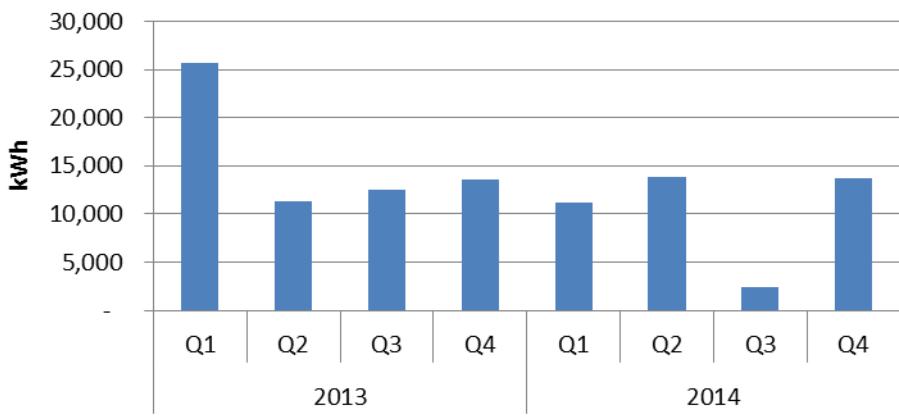
Figure 4.1 Quarterly electricity consumption 2013 - 2014

4.4 The billing data indicates a high but relatively stable electricity consumption, with most quarters being within 11,000 – 13,000kWh (see Figure 4.1). Q1 2013 at 25,710kWh and Q3 2014 appear to be anomalies caused by estimated reading corrections.

4.5 There is little discernible seasonal pattern, which may be due to the fact that parts of the building are unused outside the main sports season, possibly offsetting increased demand elsewhere in the building.

4.6 Total annual electricity use was 65,123kWh in 2013 and 43,037kWh in 2014. There is no known operational explanation for the large fall in consumption, but it is suspected that the high 2013 figure is boosted by the abnormally high Q1 reading, which is thought to be a correction of earlier underestimations.

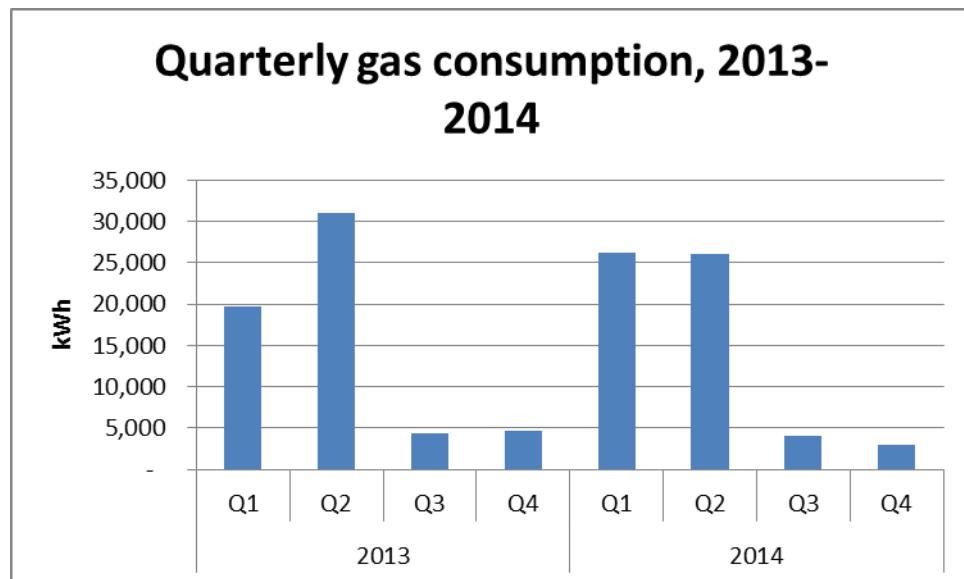
Figure 4.2 Quarterly gas consumption 2013 - 2014

4.8 The high usage in Q1 for both years (19,773kWh and 26,230kWh) is consistent with high heating in the Dec – Feb winter period, but the lowest quarterly total is Q4 2014 at 2,935kWh and both years have high consumption for the second quarter. This latter finding is probably related to increased use of the sports facilities in the March – May period, and other anomalies may be related to varying usage patterns or estimated readings and subsequent corrections.

4.9 Total annual gas consumption was remarkably stable at 59,829kWh and 59,810kWh for 2013 and 2014 respectively.

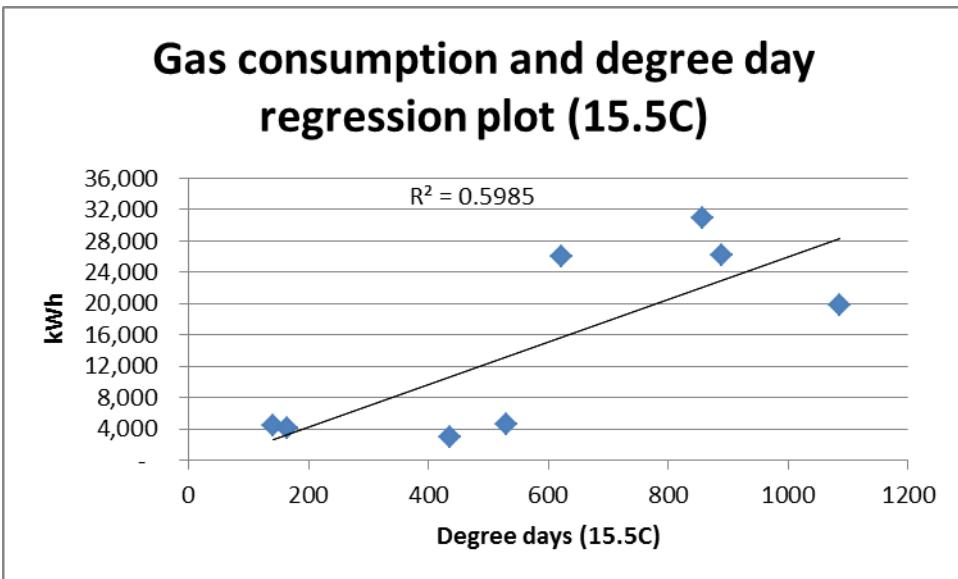
Figure 4.3 Quarterly gas consumption against degree days 2013 - 2014

4.11 Figure 4.3 below shows gas consumption plotted against degree days. This shows a weak relationship with energy consumption rising with cooler conditions (higher degree days).

4.12 This analysis shows the relationship between ambient temperatures and heating consumption is not particularly close. Figure 4.3 is a regression plot where the R^2 value represents the level of correlation between the degree day and kWh variables. A value of 0 represents no correlation at all and 1 represents a perfect correlation. The closer the R^2 value is to 1 the greater the explanation of gas consumption by degree day levels and in this case, $R^2 = 0.5985$ suggests the correlation is weak, with weather conditions accounting for barely over half of the gas consumption variation.

4.13 This may be largely explained by the seasonal nature of the activity within the building, and care must also be taken given the possibility that readings have been distorted by periodic estimates.

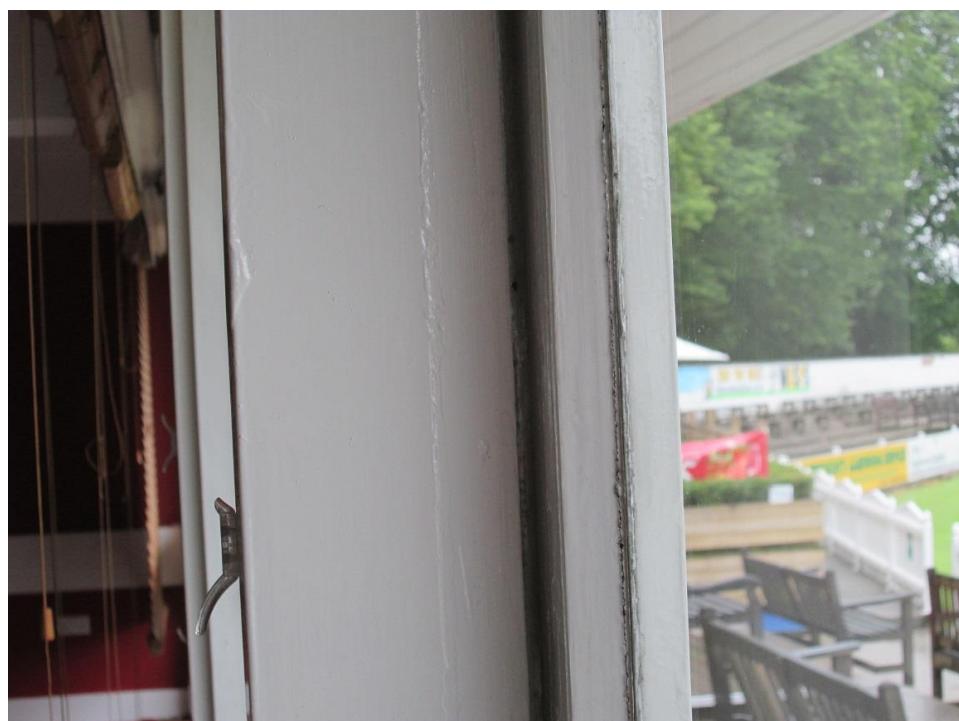
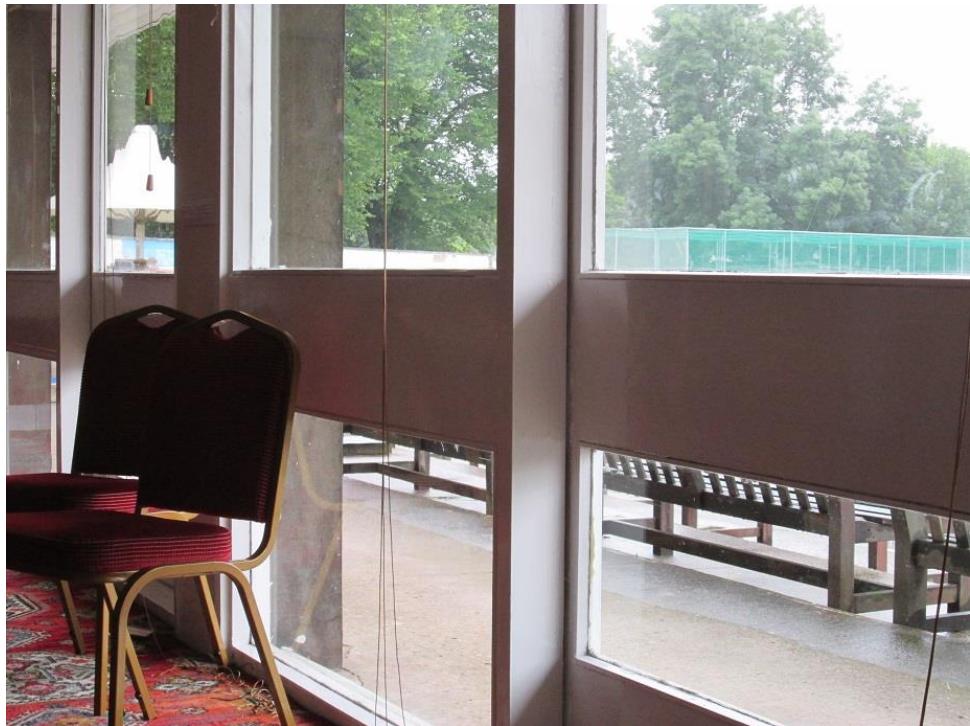
5.14 This option could only be applied to the fixed windows, and would need to be designed in conjunction with any replacement doors. The existing sliding doors represent a very significant issue, as in common with many sliding door designs, there is an opportunity for large draft gaps to emerge between the sliding and fixed sections. Figure 5.2 shows one of the sliding doors with an extremely large distance between the sliding and fixed sections, while Figure 5.3 shows an internal detail of the ground level glazing.

Figures 5.2 and 5.3 Sliding door in Pavilion Suite showing excessive air gap and ground level glazing detail

5.16 With four sliding doors currently, around half the total length of the room can be opened up. If this could be replaced with two patio style inward opening doors, with infill wall to rail height and double glazed units elsewhere, the amount of both fabric heat loss and drafts would be severely curtailed.

- 2) Replace remaining single glazed windows with double glazed units.
- 3) For the Pavilion Suite, consider the complete replacement of the south west façade, with reduced door openings and conventional insulated block wall to rail height.

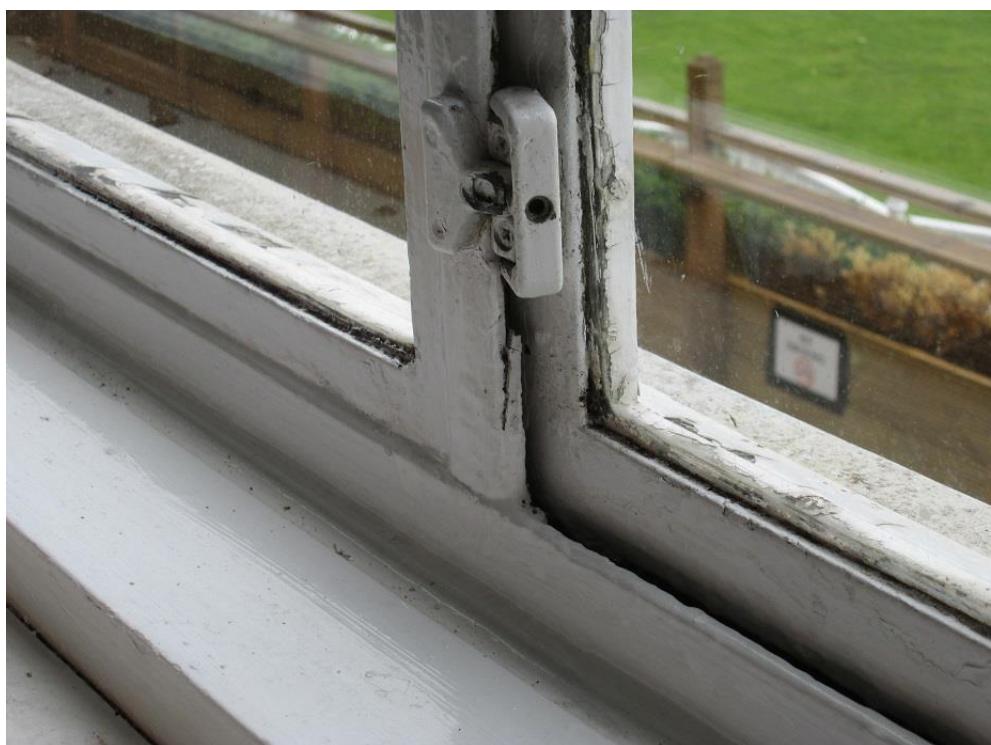
5.17 Windows in the bar area are also single glazed, but within metal framed windows. These are inherently energy inefficient, but an added problem commonly found in this type of frame is distortion over time leading to a poorly fitting closure mechanism (see Figure 5.4).

Figure 5.4 Metal window frames with gaps, bar area.

5.18 In winter, a simple secondary glazing layer is fitted, but ideally these windows should be replaced with modern double glazed units with adequate draft proof fittings.

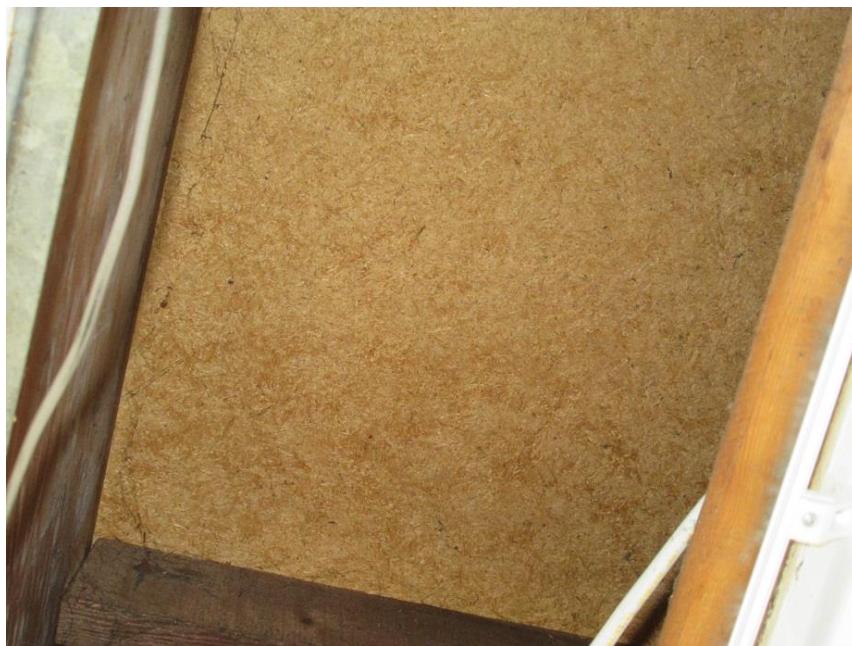
5.27 The presence and condition of roof insulation gives some cause for concern. Figure 5.5 shows an image of the main ceiling from the top of the main stairs, showing what appears to be the underside of the main roof structure through a broken internal ceiling tile. Given the construction date, it is unlikely that there is sufficient insulation incorporated into the roof structure itself, and there is no evidence of insulation within the internal ceiling layer either.

Figure 5.5 Underside of roof, top of stairs

5.28 As previously noted, the upper level is not used extensively within the main heating season, so major spending on roof insulation

may not be a cost effective use of resources. However, the proposed alterations will provide an opportunity to add insulation to those areas likely to be in more regular winter use, such as the meeting room and office. In these areas, some additional insulation would be helpful.

5.32 It may be possible to consider some internal insulation above those areas in regular winter use, but more detailed advice should be sought from an architect before making any firm decisions.

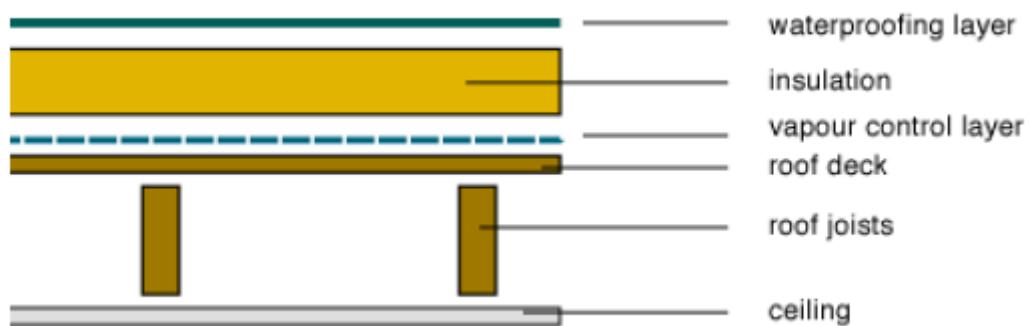
5.30 The alternative is to adopt a 'warm deck' approach, where insulation is added to the external roof area (see Figure 5.6).

Figure 5.6 Example 'warm deck' insulation

5.31 The difficulty with this approach is that it requires the roof to have sufficient strength to accept the load as well as the access required, and this solution is also difficult to apply in small sections, with insulation of the entire roof area more appropriate.

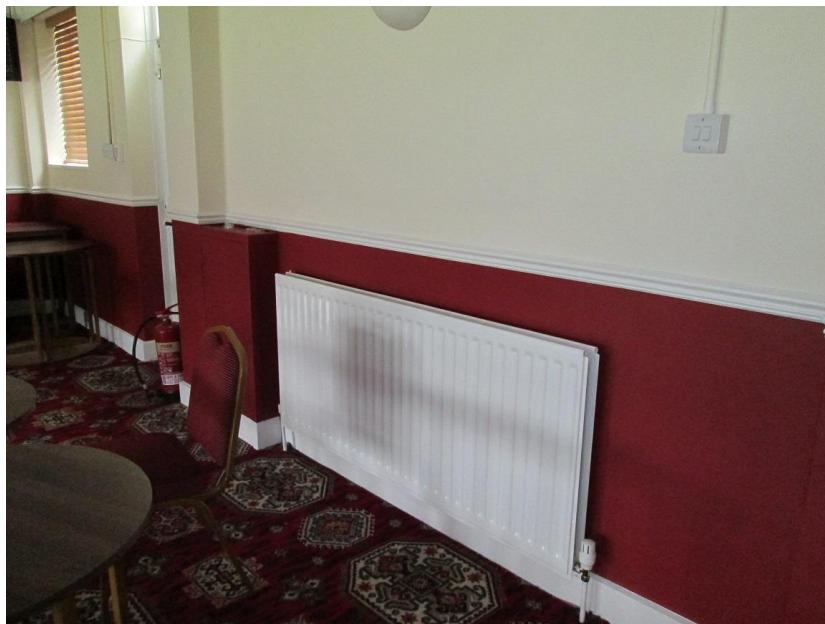
6.15 The radiators noted were reasonably effective, but the system would be improved if these were upgraded to new heat emitter units. However, it is not felt that this is a key priority if budgets are limited.

Figure 6.1 Pavilion suite radiator with TRV control

6.16 One simple measure would be to fit reflective radiator panels behind all radiators against external walls. These work to reflect heat back into the room and insulate the walls, and can increase system efficiency by up to 14%. 'Heatkeeper' panels are one example (see <http://heatkeeper.co.uk>) but there are many other versions available.

6.19 An alternative and cheaper option that provides some level of zoning may be to replace some of the TRV valves with programmable TRV heads that enable specific timings to be set for different radiators. There are also options for wireless controlled TRV valves (see <http://www.honeywelluk.com/products/Valves/Thermostatic-Radiator-Valve/Electronic-TRVs/evohome-zoning-pack/> for one specific system example) which may allow a retro fit zoning solution that would involve minimal disruption and cost in changing the TRV heads only.

- 16) Fit reflective panels behind all radiators fixed to external walls.
- 17) Ask the boiler service engineers to identify and label clearly (either on a diagram or by attaching actual labels to the physical heating system) all the control elements of the heating circuits. As part of this, they should be asked to check the apparently redundant room thermostats with a view to repairing or replacing these if a working solution remains available.

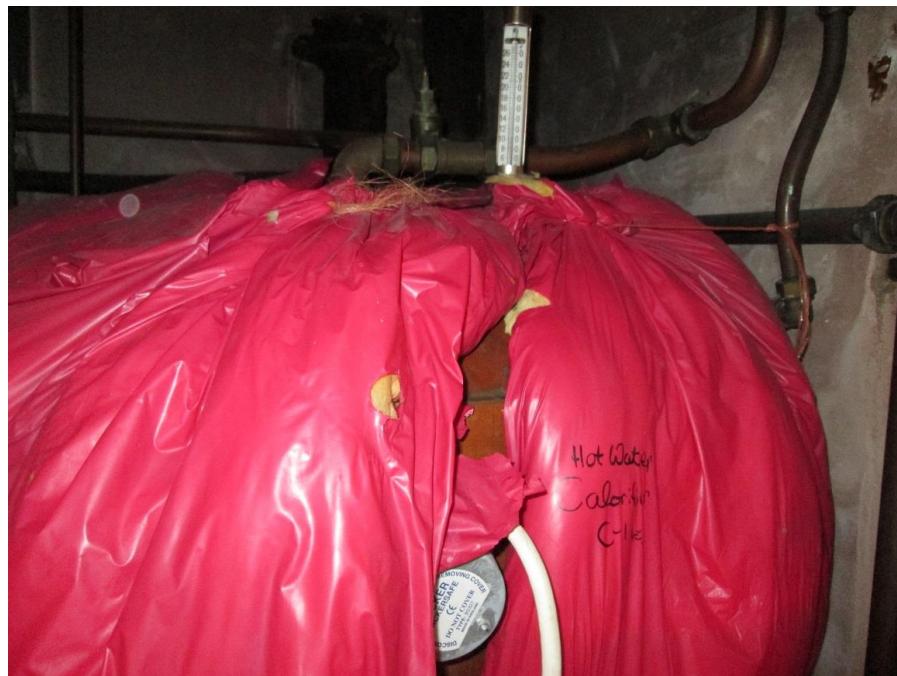
Figure 6.2 Existing hot water cylinder

6.24 The only additional point of note is that the current insulation on the cylinder is extremely poor, with rapid heat loss making this system very inefficient. As a temporary measure before the system is replaced, it is recommended that additional insulation is fitted. This could be achieved cheaply by using old duvets or blankets tied around the tank.

6.23 It is understood that this is being replaced as part of the redevelopment, and it is recommended that this system is replaced with a simple feed from the new gas boiler as the most efficient and cost effective system.

- 20) The replacement HW system should ideally be fed from the new gas boiler, with a sufficiently large HW calorifier (cylinder) to enable the boiler to provide the large volumes of water required.

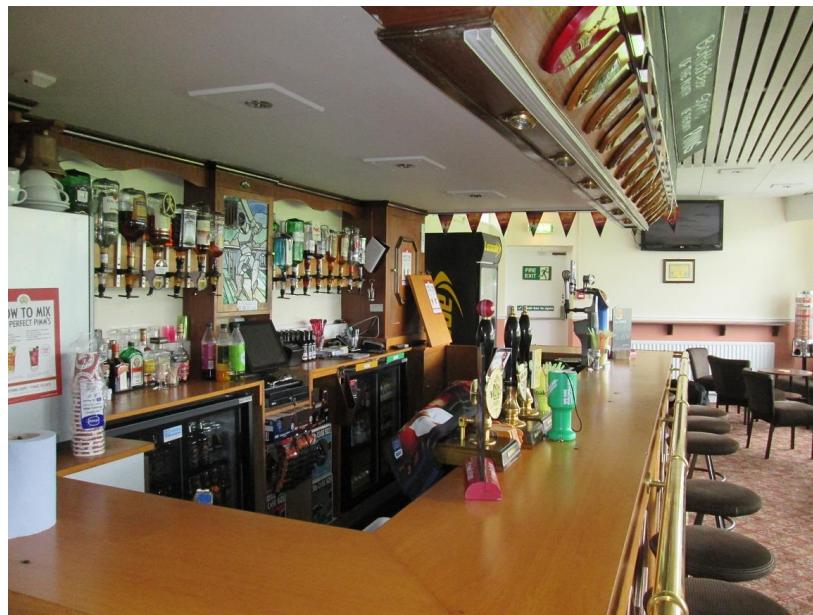
7.2 The exception to this was the bar area. Here, the whole area was fitted with recessed spot lights (see Figure 7.1). These are not ideal for providing wide area coverage and are more suitable for restricted area task lighting, and as a result more lamps are required for the adequate lighting of large areas. There were 25 fittings within the bar room, with additional lights above the bar itself.

Figure 7.1 Bar area with recessed spotlights

7.3 The lamps at the bar itself have been replaced with LED fittings, reducing significantly the energy consumption, but the lights elsewhere in the room appear to be 50W halogen type bulbs, suggesting a standing consumption of around 13kW for the room as a whole when lit.

7.4 This is a high energy demand, and consideration should be given to replacing these with low energy LED variants, or if brighter ambient light is required, at least reducing these to 30W halogen lamps.

- 22) Replace spot lights in bar with lower capacity halogen or preferably LED bulbs to significantly reduce electricity demand.
- 23) Check fridges and freezer compressor units and cooling fins are clean and free from dust and that there is adequate circulation space around the cooling system.

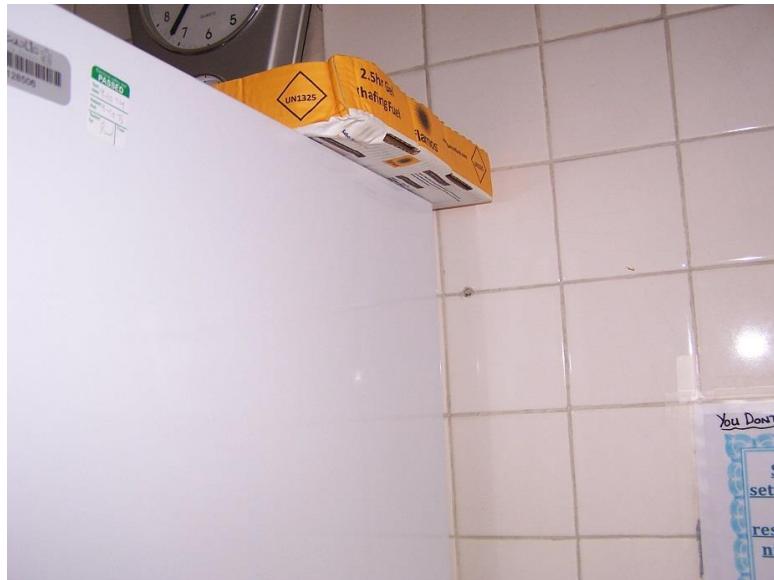
8.4 This may mean easing the unit away from the wall slightly to allow better air circulation, as fridge and freezer units are commonly placed too close to walls (see Figure 8.1).

Figure 8.1 Example of fridge placed very close to the wall (not from this building)

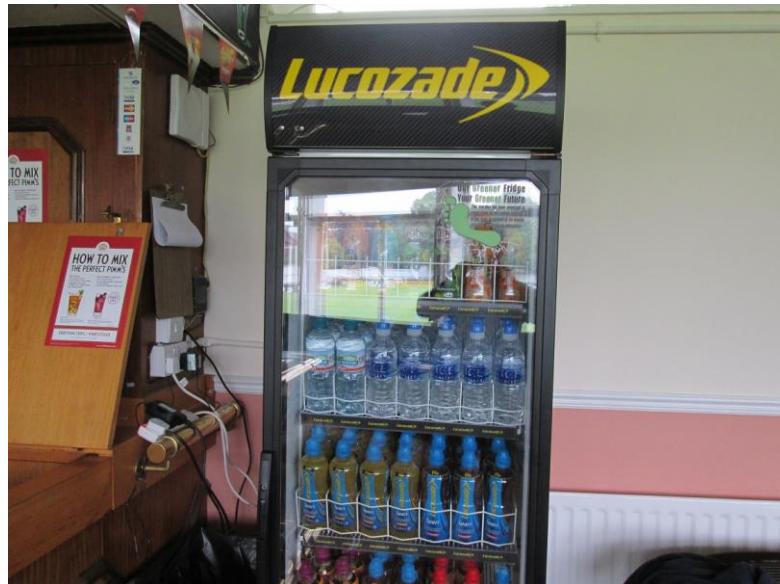
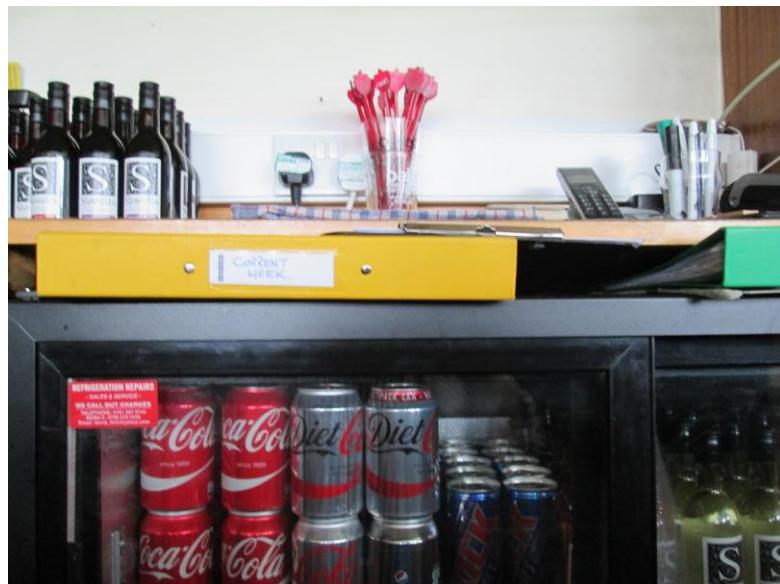
Figures 8.2 and 8.3 Chiller units

8.11 It was also noted that the temperature of the chillers was set to a very cool temperature. While certain drinks may be favoured at such temperatures, the bar management should consider whether the temperature needs to be this cool, but this will require an assessment of customer attitudes. One option would be to rearrange the chillers so that those drinks requiring very cool conditions are placed into a single chiller, with other products able to tolerate slightly warmer temperatures grouped into the remaining units. Every 1C rise in fridge temperature can save 15% of the energy used, so such a move could be highly beneficial.

8.12 Figure 8.3 also indicates a common issue with bar chillers, where there is often very limited space beneath the bar and around the unit to allow adequate air circulation. This is important for efficiency, as

8.13 While there is little that can be done in terms of the bar design, it was noted that a number of files were placed on top of the chillers between these and the bar top itself, effectively cutting out any air circulation. These should be relocated and the air gap kept open as much as possible, with the units pulled slightly forward as well if at all possible.

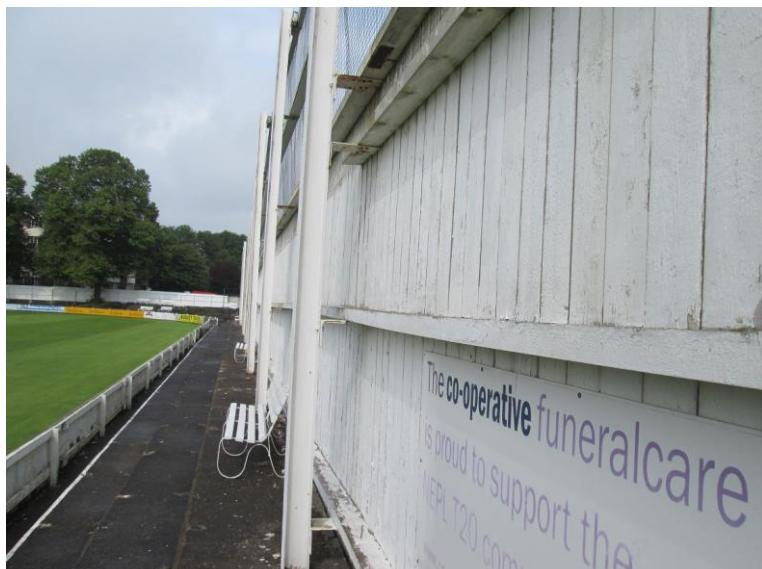
11.14 A second option would be to consider vertical or near vertical panels installed on the site screens at the north end of the ground. Figure 11.1 shows a detail of the structure of these screens, and it would be possible to bolt fix the panels to a frame mounted on the vertical steel supports.

Figure 11.1 Site screen detail

11.15 Two key problems would need addressing. Firstly, the panels would be highly vulnerable to damage from cricket balls, and would therefore need screening with rigid or semi rigid mesh to protect them. While this would be possible, any shading onto PV systems has a significant effect on performance, and a mesh lying close to the panels would create significant shadow. If the system is adequately protected, it could therefore mean the output is unduly impaired.

11.16 The second issue is the loss of efficiency from high angle (vertical) panels. The ideal orientation is 30 degrees from horizontal, and at 90 degrees the panels would be highly inefficient, to the point of being unviable. Even at 60 degrees, there would be a significant reduction in output, but protruding at this angle from the uprights would be sufficient to introduce difficulties in providing adequate screening as
